SEM ANALYSIS ZIRCONIA-CERAMIC ADHESION INTERFACE

Objectives. Modern dentistry increasingly tends to use materials aesthetically acceptable and biomimetic. Among these are zirconia and ceramics for several years, a combination that now has becoming synonym of aesthetic; however, what could be the real link between these two materials and especially its nature, remains a controversial topic debated in the literature. The aim of our study was to "underline" the type of bonding that could exist between these materials.

Materials and methods. To investigate the nature of this bond we used a SEM microscopy (Zeiss SUPRA 25). Different bilaminar specimens: "white" zirconia Zircodent® and ceramic "Noritake®", after being tested with loading test in bending (three-point-bending) and FEM analysis, were analyzed by SEM. Fragments' analysis in closeness of the fracture's point has allowed us to be able to "see" if at large magnifications between these two materials, and without the use of linear, could exist a lasting bond and the possible type of failure that could incur.

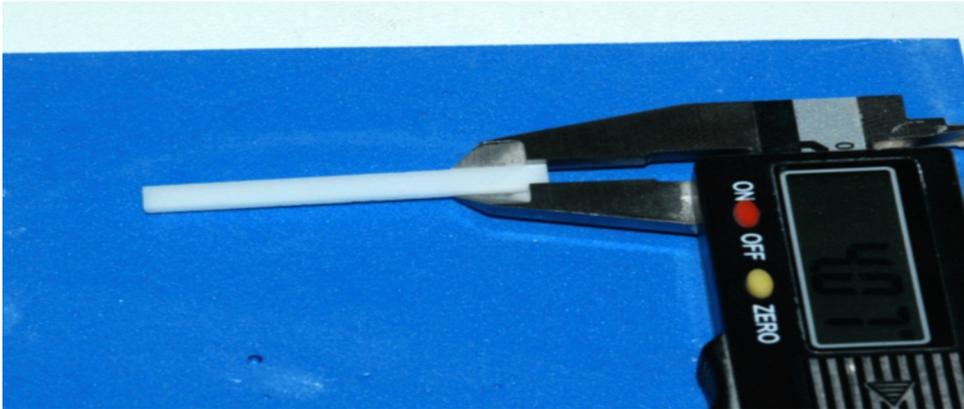
Figure 4
Specimen width.

during the sintering oven to 15000 C, therefore we recommend the use of suitable supports that support the structure without impeding the movement (Figures 4-6).

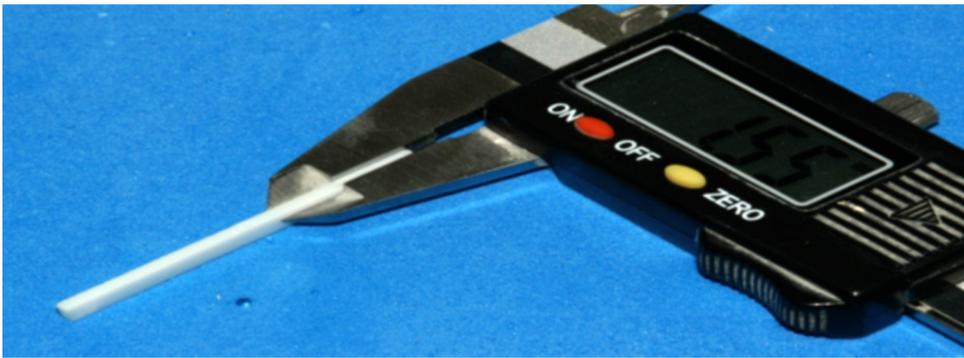
Figure 5
Specimen's thickness.
