# A NOVEL TECHNIQUE TO CLOSE LARGE PERFORATION OF SINUS MEMBRANE

M. CLEMENTINI, L. OTTRIA, C. PANDOLFI, P. BOLLERO

Department of Clinical Science and Translational Medicine, University of Rome "Tor Vergata", Rome, Italy  
U.O.C. of Odontostomatologic Clinic - Director and Chief: Prof. Alberto Barlattani

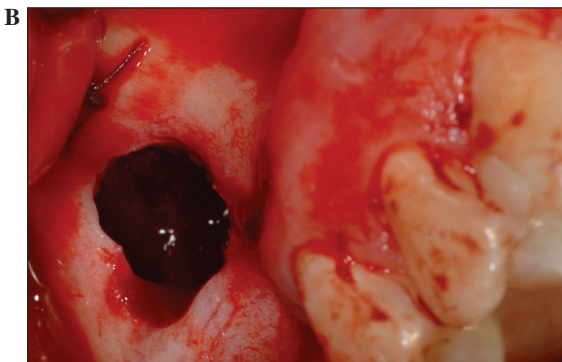
**Figure 4**

**A)** The obliteration of the perforation was obtained through suturing sinus membrane with a resorbable material to the bone directly lateral to the osteotomy site. **B)** The obliteration of the perforation was obtained through suturing sinus membrane with a resorbable material to the bone directly lateral to the osteotomy site.

It was decided to remove the root before starting the regenerative procedure. During the extraction, a perforation of sinus membrane occurred (Fig. 3). It was located in the mid superior aspect of the osteotomy, extending mesiodistally for two-thirds of the dimension of the total osteotomy site. Because of a collagen membrane wasn't available, the obliteration of the perforation was obtained through suturing sinus membrane with a resorbable material to the bone directly lateral to the osteotomy site (Fig. 4A, B), giving the chance to not abort sinus augmentation procedures and to place the graft material (Fig. 5). Finally detached sutures were positioned (Fig. 6).

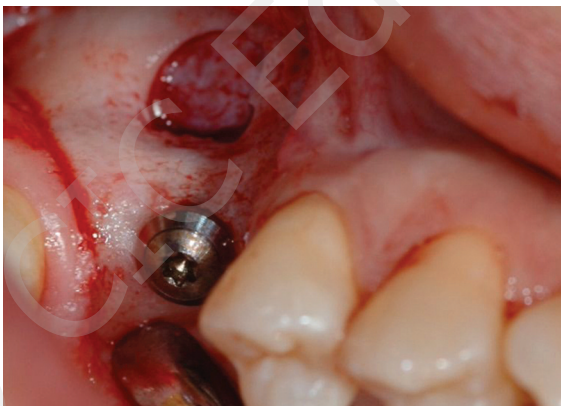
**Figure 7**  
The placement of a osseointegrated implant.

ams after 6 months revealed a good quantity of bone to receive an implant, so an osseointegrated implant was placed (Fig. 7) and the patient was rehabilitated with a PFM crown (Fig. 8). The intraoral radiographic control (Fig. 9).

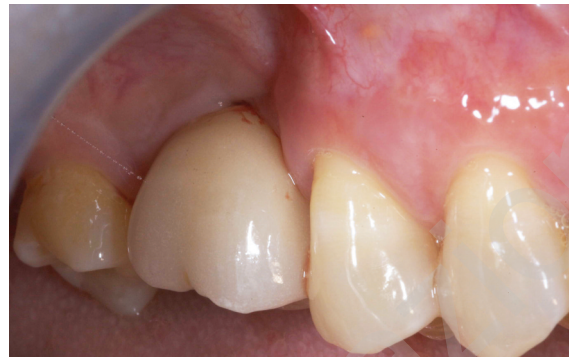
**Figure 8**  
The rehabilitation with a PFM crown.

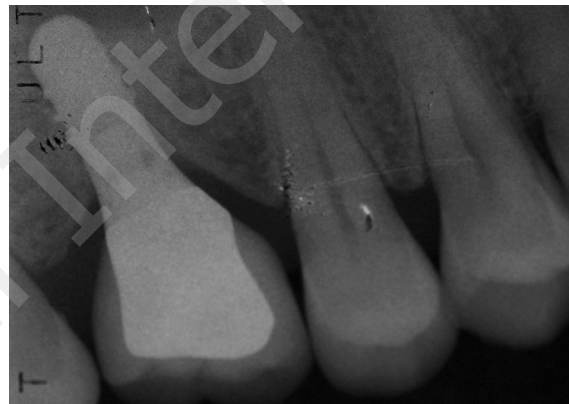
**Figure 9**  
The intraoral radiographic control.
